Silt Facility Statistics	
Nearest Town:	Silt
County:	Garfield
River Basin:	Lower Colorado
Receiving Water Body:	Colorado River
Year Online:	1992
Population:	1700
Elevation (feet):	5700
Design Flow (mgd):	0.236
Average Flow (mgd):	0.110
Size (acres):	0.83

Facility Description

The Silt wastewater treatment facility is a domestic minor municipal lagoon system. The system consists of influent Parshall flume for flow monitoring, two aerated lagoons, a polishing pond, surface flow constructed wetlands, chlorine gas disinfection, and a V-notch weir for effluent flow monitoring.

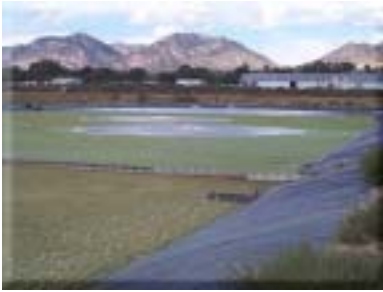
View of lagoons

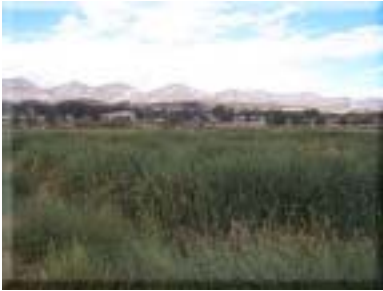
Wetland cells

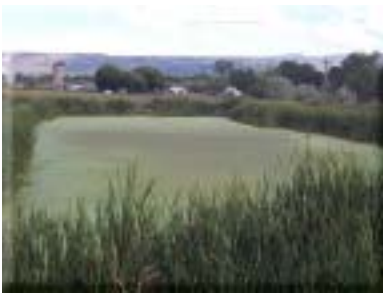
Sunken wetland cell

The wetland cells were originally designed to be able to be dewatered. Unfortunately, the bed of the wetland cells sank about 18" due to the weight of the wetland media, vegetation and water. This resulted in areas within the wetland that cannot be dewatered. Pea gravel was added to two of the cells in order to raise the ground level and allow plant establishment. The third cell was not easily accessible, and the addition of gravel was not feasible. It has standing water and large, unvegetated areas.

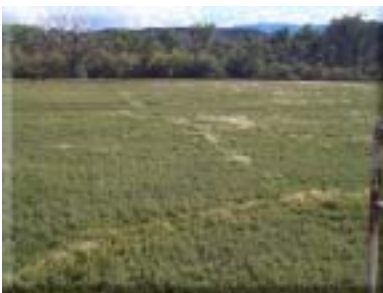
View towards discharge point

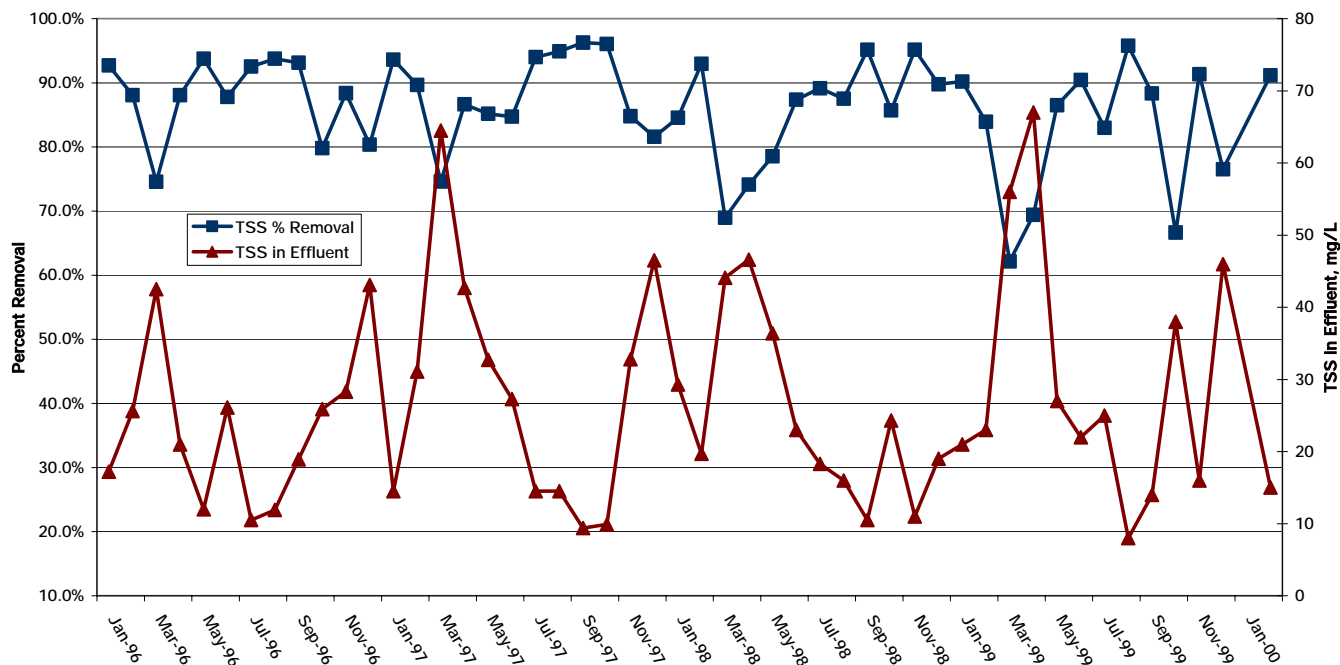
Silt TSS Performance

The TSS graph plots the percent removal on the left axis and TSS in mg/l in the effluent on the right axis. The average monthly TSS in the influent, during the period of record, has been 202 mg/l and the average monthly effluent has been 27 mg/l. This meets the permit discharge requirement of 75 mg/l.

Wetlands Completed November 1992

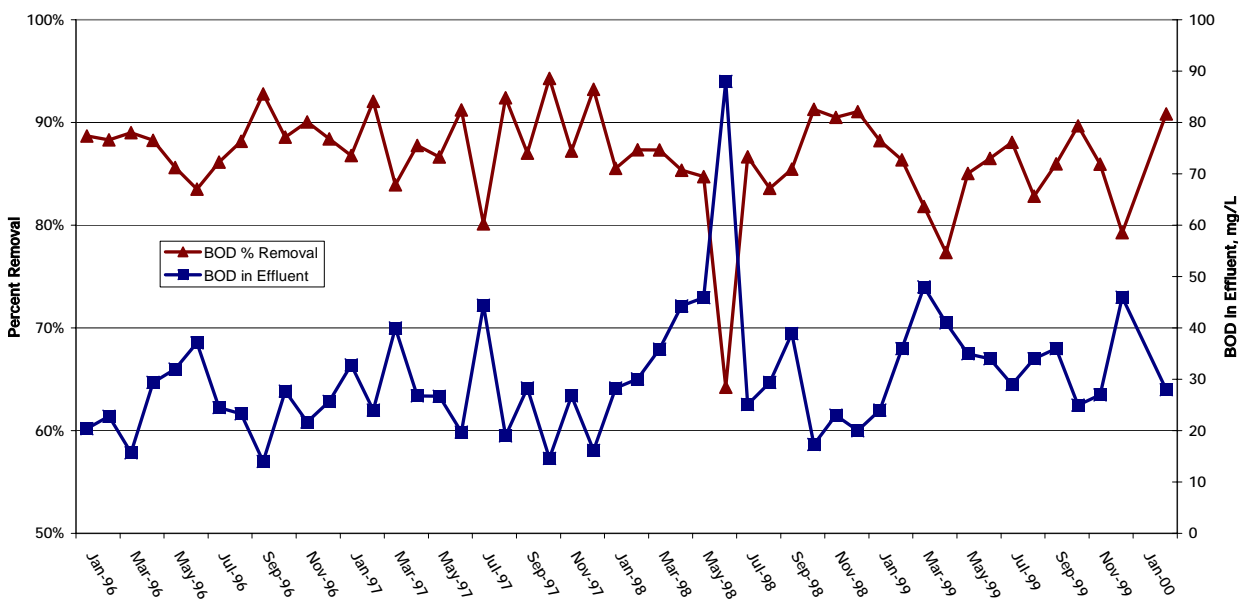
Silt BOD Performance

The BOD data is plotted similarly to the TSS data, with mg/l in the effluent on the right axis, and percent removal on the left axis. . The average monthly influent amount has been 229 mg/l and the average monthly effluent amount has been 30 mg/l. Several exceedances of the permit limitation have been experienced.

Wetlands Completed November 1992

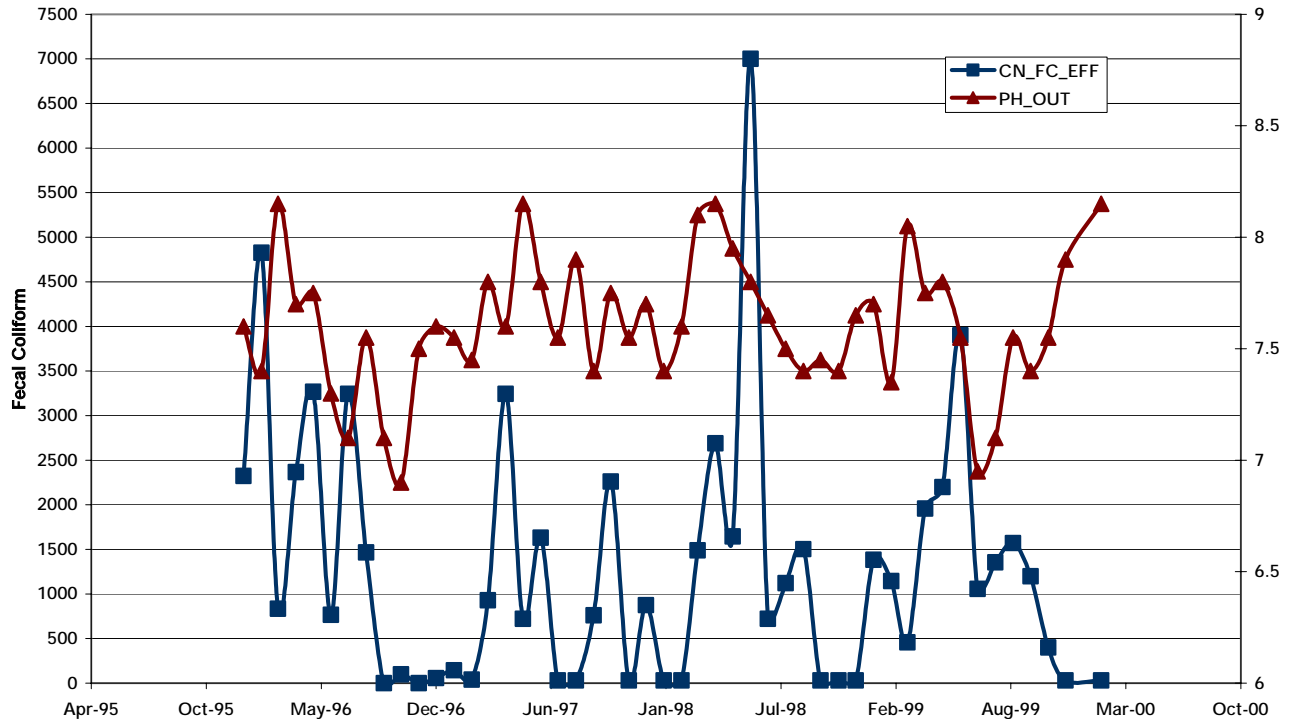
Silt pH and FC in Effluent

Data for these two categories have been plotted on the same graph. Data reflect the quality of the effluent; no influent measurements are taken for these parameters. The pH values plotted are an average of the minimum and maximum 30-day values that are reported in the monthly reports. During the period of record, pH values have consistently stayed within the allowable range of 6.5 to 9.
